Algae in the White River near Meeker

Bob Dorsett, MD
Meeker River Watch
August 2017
updated June 2019

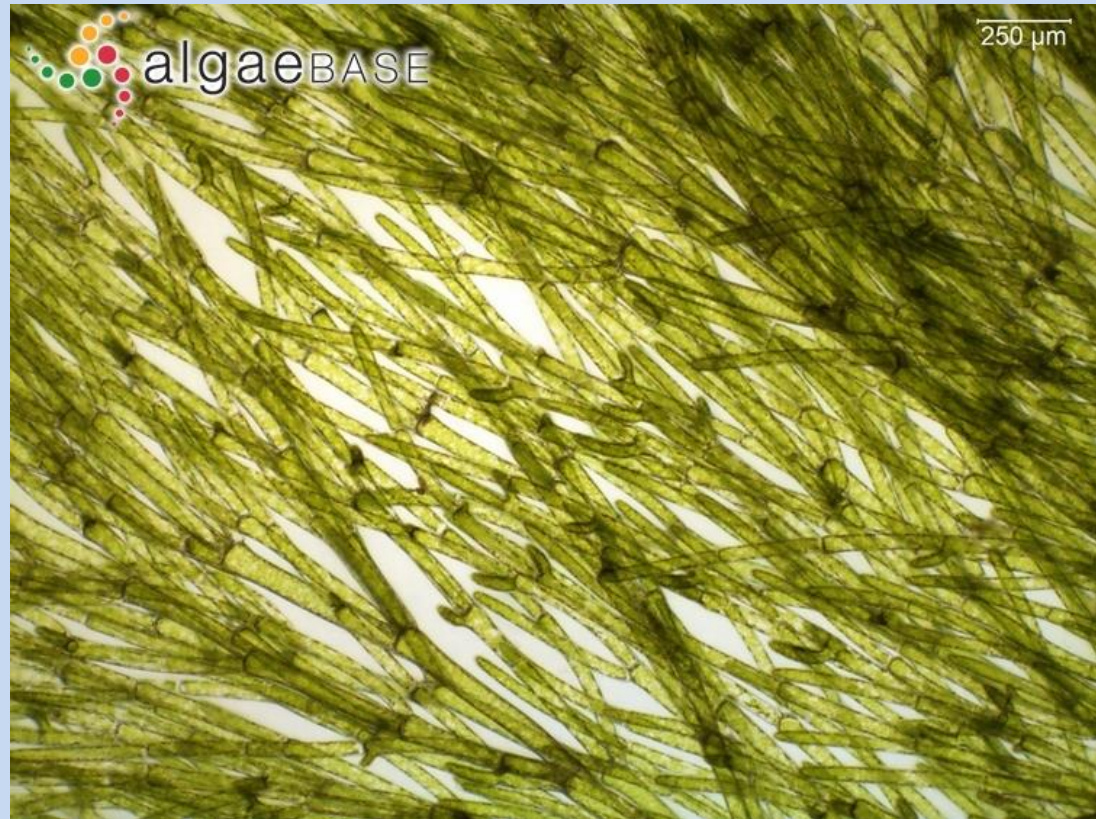
1. Overgrowth of the green filamentous algae
Cladophora glomerata

A known nuisance species that requires high concentrations of N and P

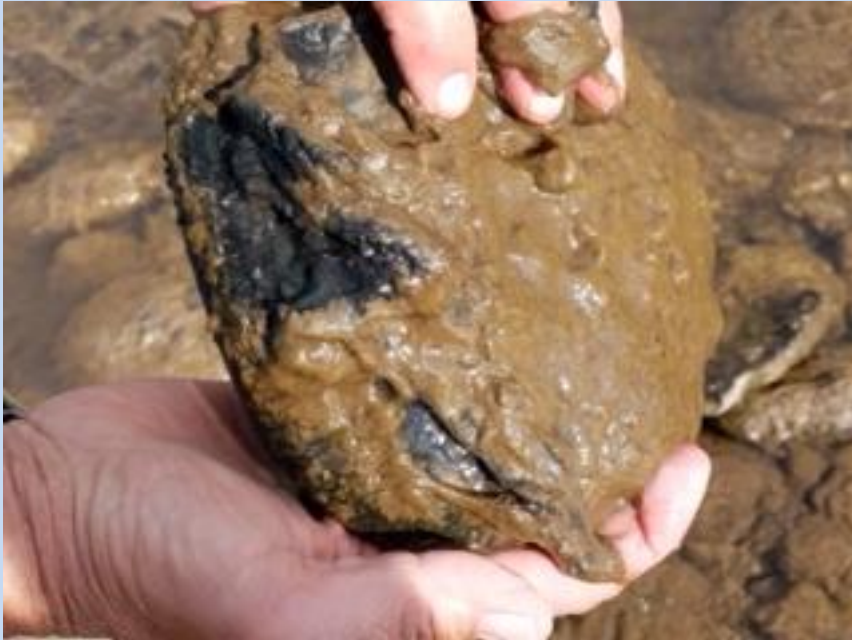
Photo by Peter Brixius

2. Diatom overgrowth, probably *Cymbella janischii* or *C. mexicana*.
(Tentative identification by Sarah Spaulding, USGS.)

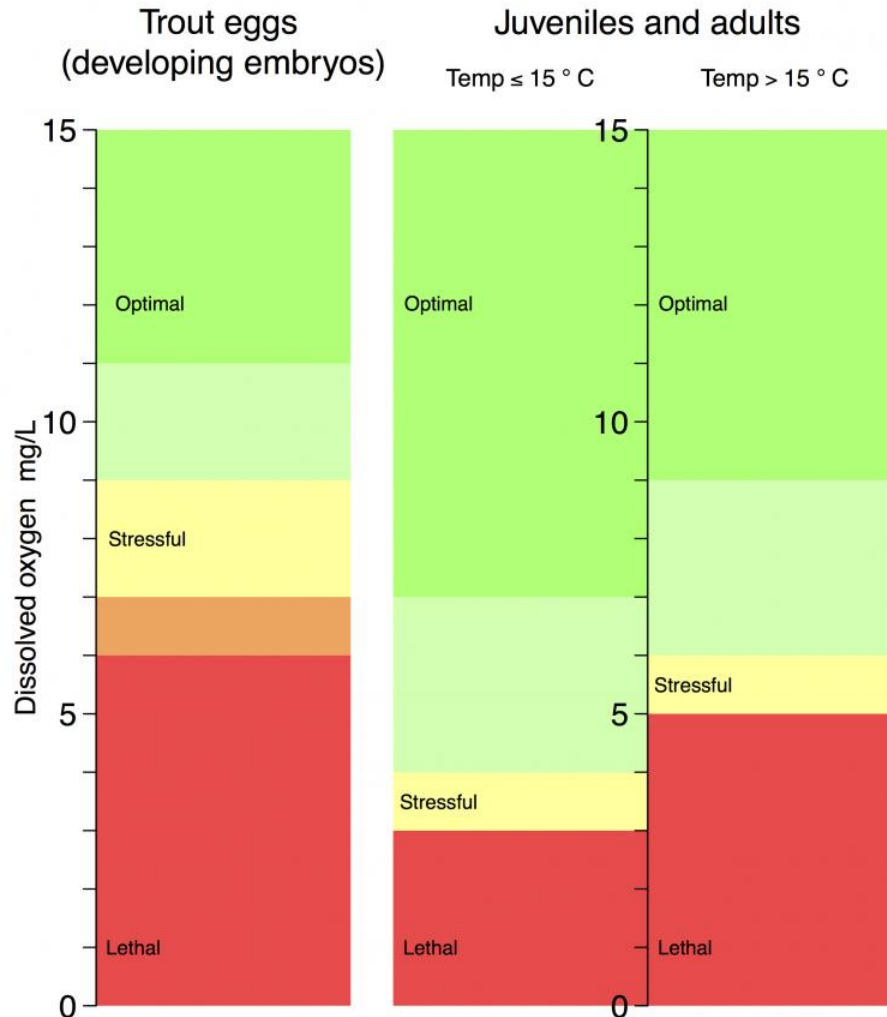
Average dissolved oxygen requirements for salmonids

Genera *Oncorhynchus* which includes Rainbow Trout and *Salmo* which includes Brown Trout

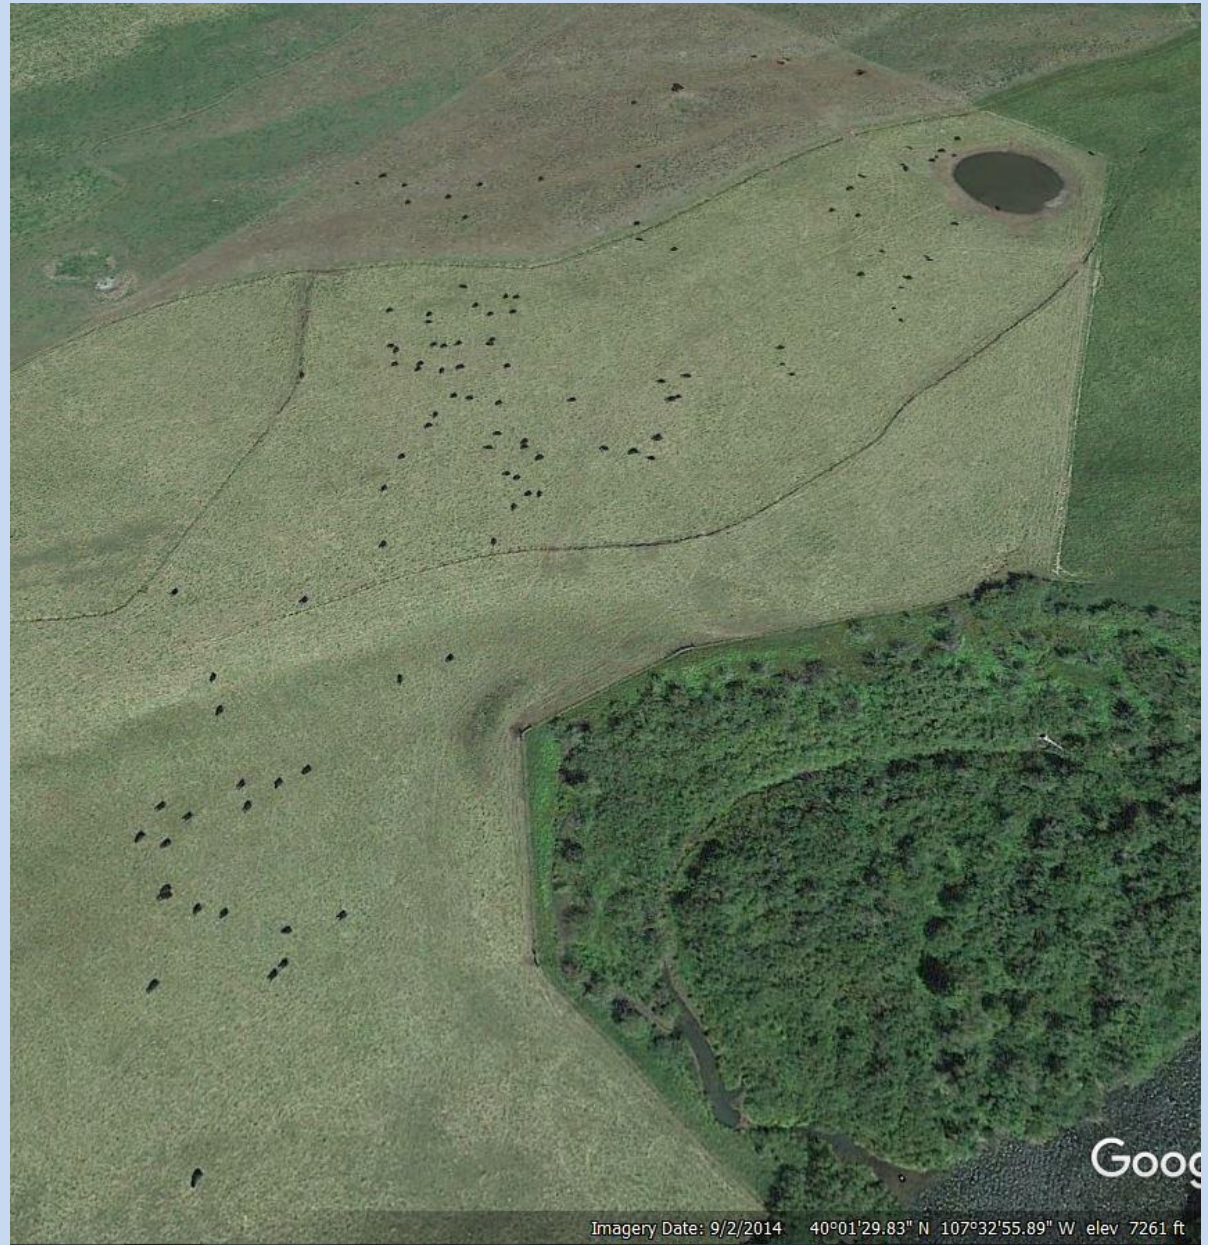
Possible sources
of excess
nutrients:
fertilizers, animal
waste, leaky
septic systems,
and fish food.

Google Earth image September 2014, upper White River

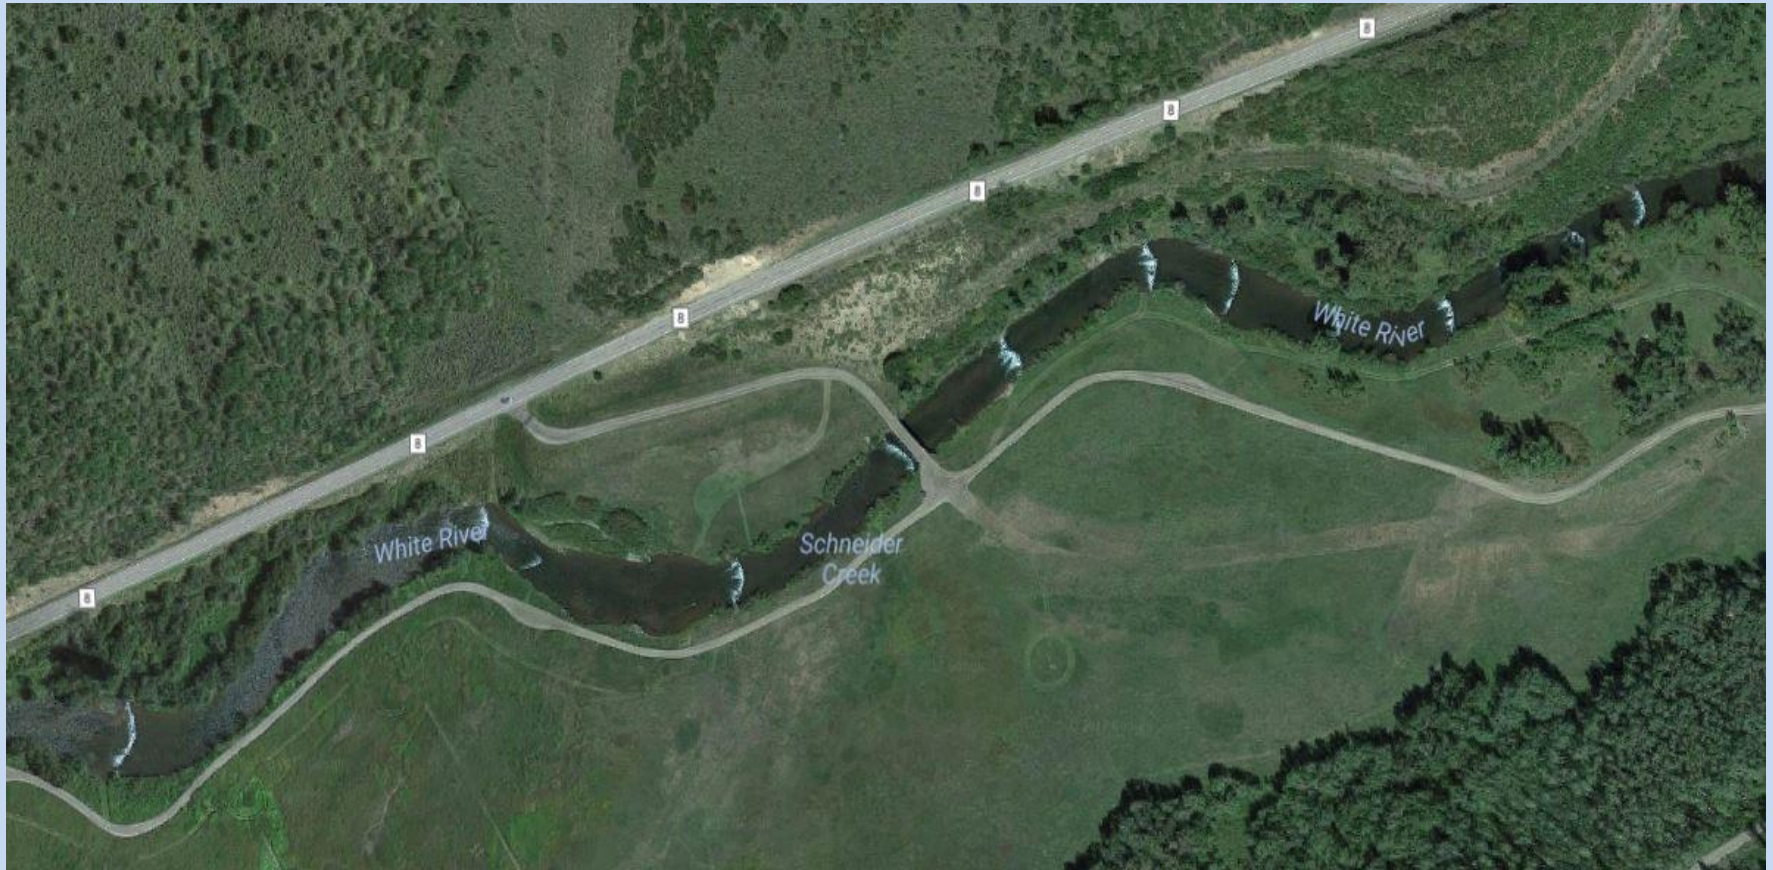
Probable contributing factor: modified river hydraulics

Constructed fish catchments on upper White River. Google Earth image September 2014.

A related question: Does dredging contribute to increased nutrient load, carried by disturbed sediments?

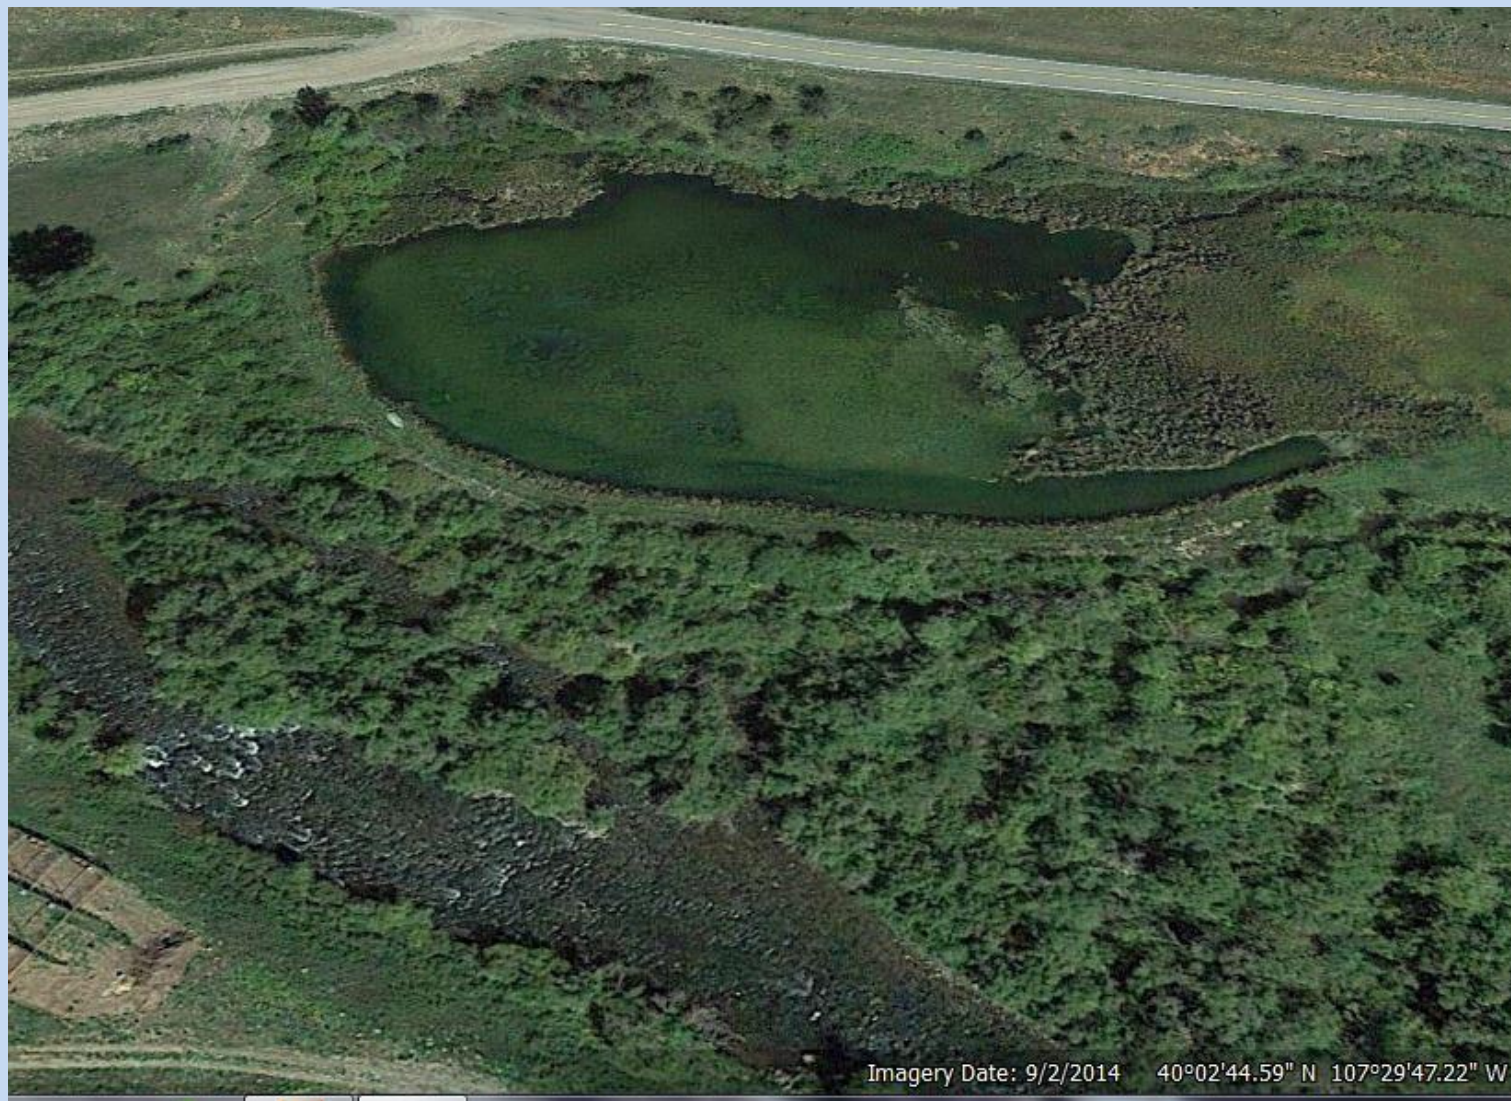
Possible factor: algae-loaded ponds draining into the river

Pond draining into upper White River. Google Earth image
September 2014

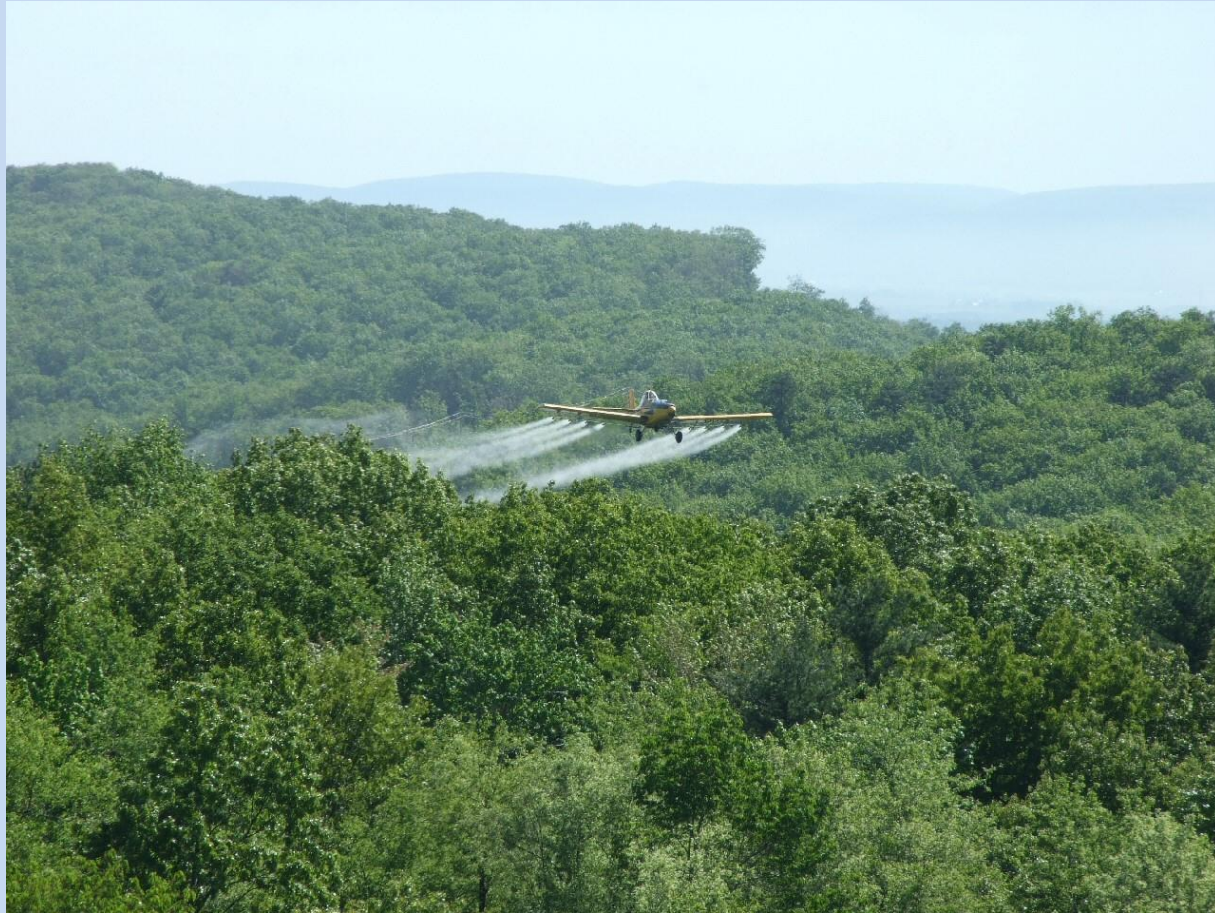
Photo credit Tallman Aerial Spraying

Possible contributing factor: insecticides

Rationale: Aquatic invertebrates graze on algae. Malathion Iv and Kontrol 30-30 (permethrin) are highly toxic to aquatic invertebrates. If invertebrate populations drop, more algae grows.

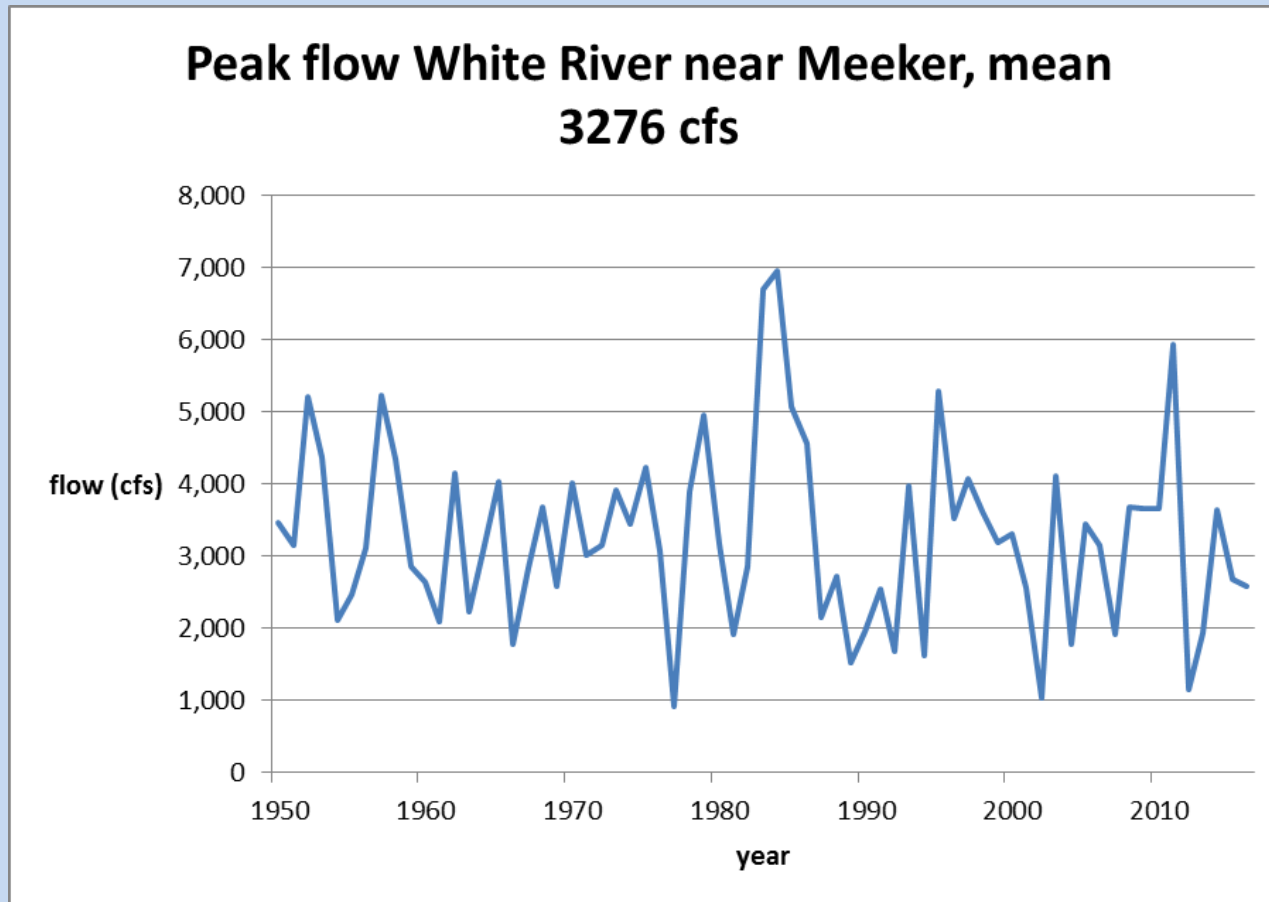
Data from USGS gauge station 09304500 Near Meeker, CO. USGS NSIP

Possible factor: decrease in scouring flows

Regression analysis shows downward trend.

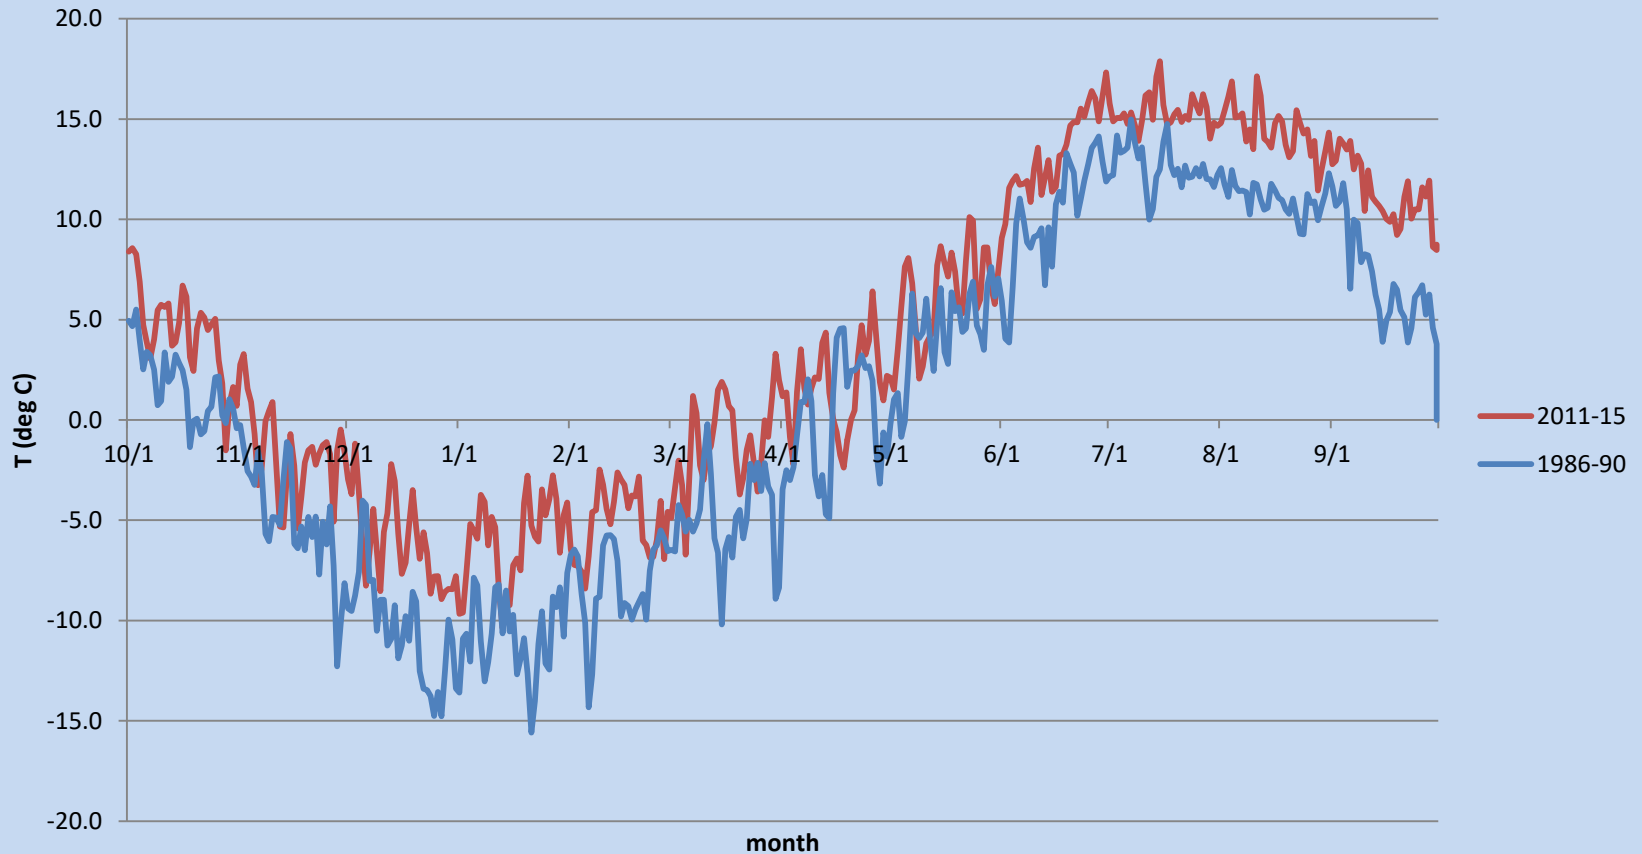
Trapper Snotel 5-year Mean Daily Temperature (deg C) 1986-90 vs. 2011-16

Winters at Trapper Lake are about 3.6 degrees C warmer today than they were thirty years ago.
